Manhole Inspection Summary

Manhole # S47II_010MH

Insp Date: **4/30/08 9:19 AM**

Location Address: **Federal St**

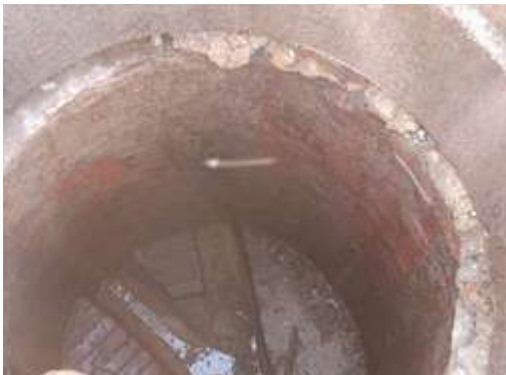
Defect 2

Condition: ☐ Sound ☐ Cracked ☐ Root Intrusion ☐ Loose Brick ☒ **Deteriorated**

Deterioration

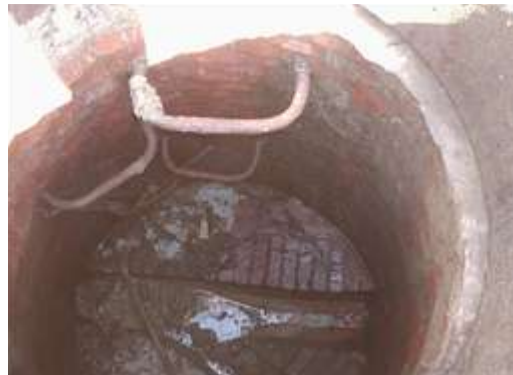
Defect 1

Infiltration: ☐ None ☒ **Joint** ☐ Cracks ☐ Mortar ☐ Roots ☐ Wall

Infiltration

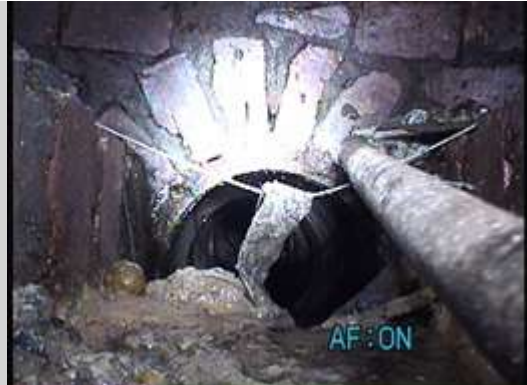
12 O'Clock Outflow

8 in. Circular Gravity Sewer
Pipe Out @ 12 O'Clock

Pipe Height: **8.4** (in.) Rod and Bar (Angled)
Pipe Material: **Clay** ☐ Pipe Lined
Invert Depth: **8.20** (ft.) Flow Characteristics: **Slow**
Deposits: ☐ None ☒ **Mud** ☐ Sludge ☒ **Debris** ☐ Grease
Silt Depth: **4** (in.) Deposits Extent: **Medium**
Infiltration: **None** Pipe Seal Cond: **Sound**

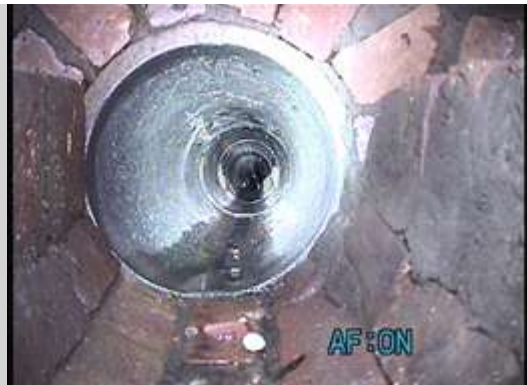
6 O'Clock Inflow

8 in. Circular Gravity Sewer
Pipe In @ 6 O'Clock

Pipe Height: **8.4** (in.) Rod and Bar (Angled)
Pipe Material: **Clay** ☐ Pipe Lined
Invert Depth: **7.60** (ft.) Flow Characteristics: **Slow**
Deposits: ☒ **None** ☐ Mud ☐ Sludge ☐ Debris ☐ Grease
Silt Depth: (in.) Deposits Extent:
Infiltration: **None** Pipe Seal Cond: **Sound**

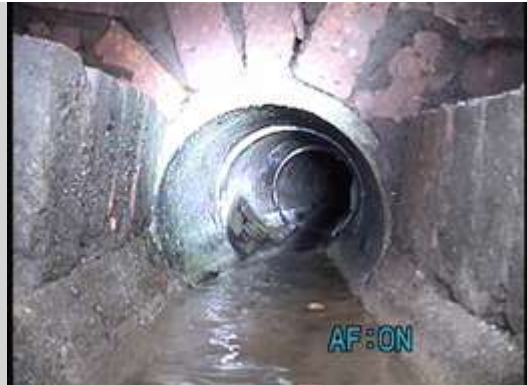
7 O'Clock Inflow

8 in. Circular Gravity Sewer

Pipe In @ 7 O'Clock

Deposits: ☒ None ☐ Mud ☐ Sludge ☐ Debris ☐ Grease

Infiltration: **None** Pipe Seal Cond: **Sound**
